Project Name: Yacyretá Hydroelectric Project

Abstract:

In August 1994, massive fish mortality was observed downstream of the project's main spillway. EBY (Entidad Binacional de Yacyretá) immediately changed the spillway operation in order to alleviate supersaturation of total dissolved gases (TDG), the cause of the mortality. The long-term solution was a change in the geometry of the spillway. No fish have died since these measures were implemented.

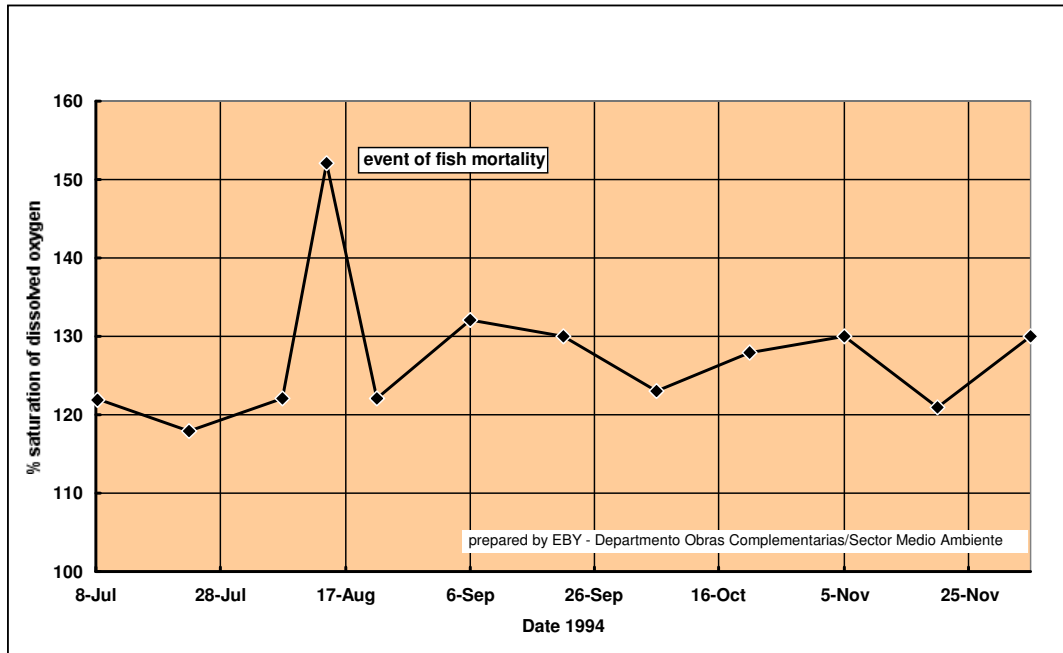
Fig.3: Evolution of dissolved oxygen in the stilling basin of the main spillway

During August 1994 a massive fish mortality was observed downstream of the main spillway. This phenomenon coincided with a change in spillway operation from unsymmetrical discharge through totally opened gates to symmetric flow through equally partially opened gates. Immediate studies indicated that the cause was gas bubble disease associated to supersaturation. The majority of the affected fish were mainly "nodorados de fondo" (catfish, scates) but also salmons, "doradores and bogas". 10 days thereafter the gates operation was changed to avoid the most critical supersaturation, Fig.3. Similarly, in October of the same year, dead fish were also observed, however in much less quantity, at

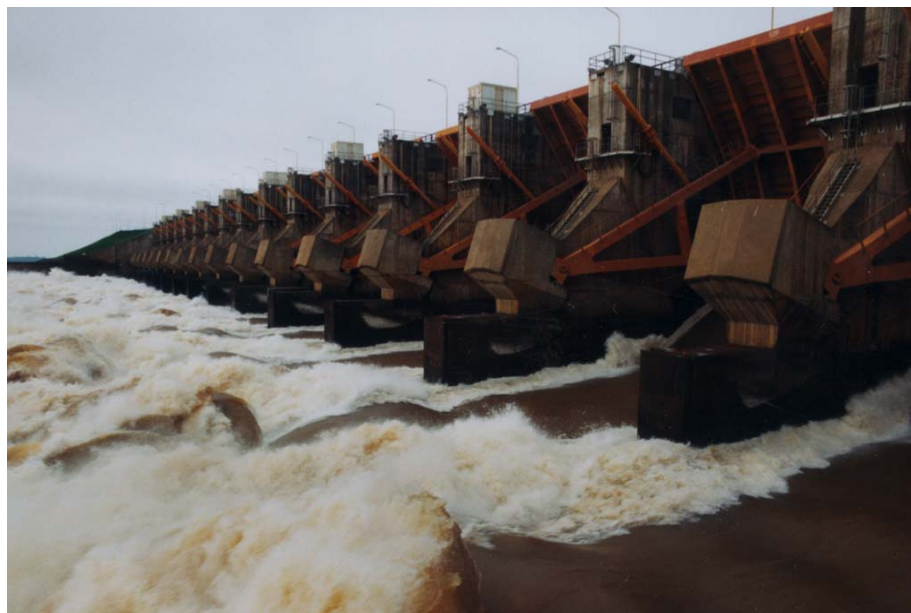
Fig.4: Aña Cua spillway operation at the time when fish mortality occurred

the Aña Cua spillway, Fig.4. There, the spillway operation was changed immediately. It should however be mentioned that critical spillway operation was restricted to the time when the power unit were still under construction and not yet ready for operation. This condition increased the spillway discharges and thus the levels of supersaturation.

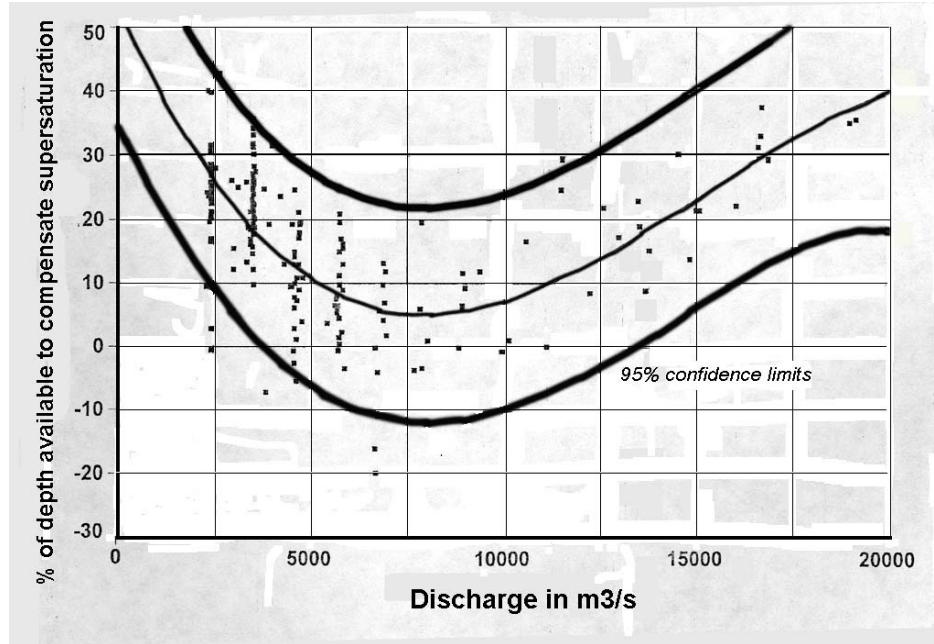
Fig.5: Depth available for fish in order to escape into regions with lower supersaturation

Correspondingly, mortality rates are related to the degree of supersaturation, the depth available for the fish and the duration of exposure time. The following threshold values were evaluated:
