3- Fish Migration and River Navigation

Chambly Dam on the Richelieu River

Project Name: Chambly Dam

Abstract:

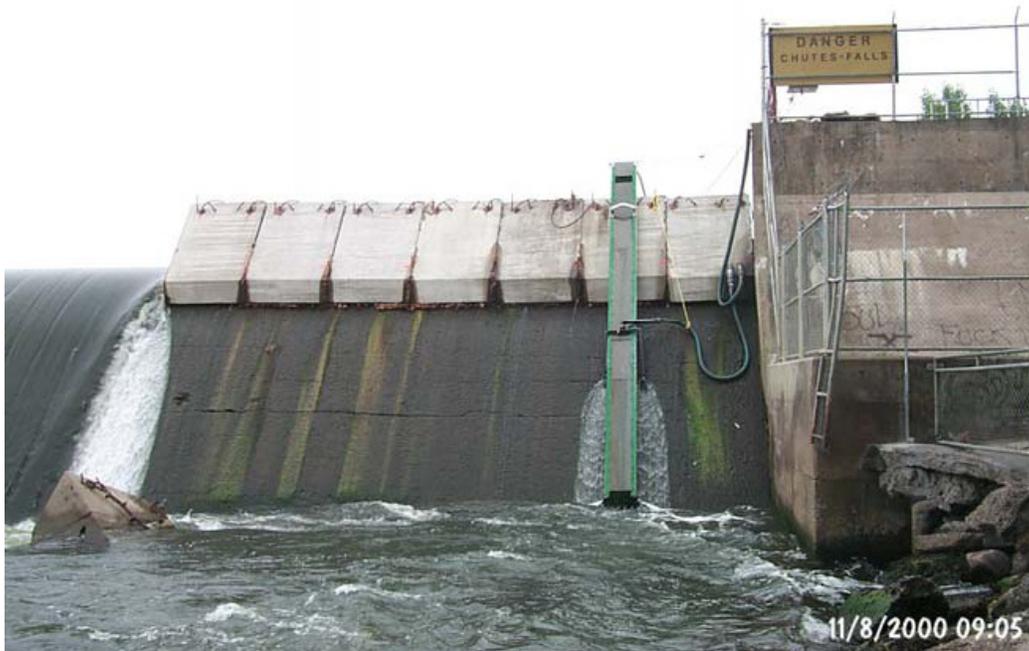
Figure 4 Photograph of the ladder

In 1997, a ladder was retrofitted on the Chambly Dam to enhance recruitment. For this purpose, a 12.6-m cutoff wall made of seven concrete blocks, each weighing 12 tons, was first installed on the weir crest, near the left river bank. This wall was necessary to stop the flow and create a relatively still area, allowing eels to swim to the foot of the dam. An eel ladder made of a wood and plastic climbing ramp, covered with staggered studs, was then fixed on the concrete wall and the down face of the dam. The ladder was 8.8-m long, 0.55 m wide, and had a slope of 51°. A submersible pump provided a flow of 0.6 L/s on the climbing ramp, while an additional attraction flow of 14.4 L/s was provided by gravity at the entrance. In 1998 and 1999, the design was improved by widening the entrance to 1.1 m and eliminating the leaks through the cutoff wall. In 1997 and 1998, a live trap at the ladder outlet captured the migrating eels, while a photoelectric counter was installed in 1999. At the outset, the electronic counts were validated with manual counts, and thereafter processed to eliminate false signals.
