ANNEX 11 Renewal and Enhancement of Hydroelectric Installations

Format for the 2nd Round Data Collection (Definition of Case Histories)

The renewal project of the control and monitoring system of the Okawachi Hydropower Station

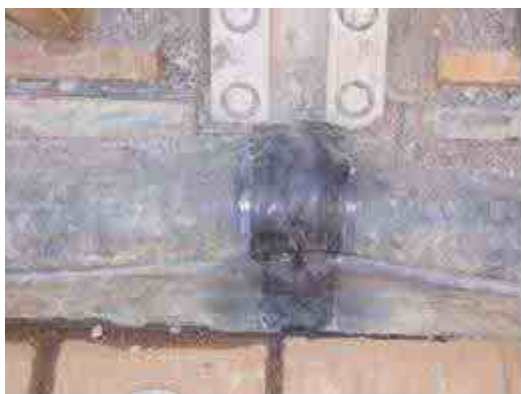
Photo 12: Repair of the connection area of the rubber gasket cover

2 years after operations began a gate inspection was conducted by removing water. No damage or abrasion was found (Photo 10). At the connection area of each unit, peel-off of the naturally vulcanized rubber which was placed on the site was found, and from that gap, fine sand had entered (Photo 11). Then, by opening the rubber gasket cover, the interior of the rubber gaskets was inspected, and no damage by intruding sand and gravel was found, and the conditions were sound (Photo 11). Incidentally, the connection area of each unit was again repaired with naturally vulcanized rubber after removing the sand and gravel inside the fixing rubber cover (Photo 12).

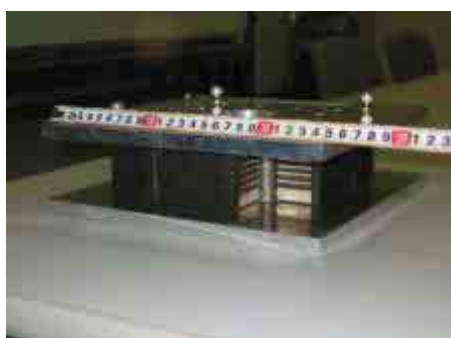
Fig. 6: Model of Aseismic rubber bearing (LRB)

As an Aseismic bearing, the LRB (Lead Rubber Bearing: laminated rubber bearing containing lead plug) shown in Fig. 6 was adopted. The LBR has a structure in which a lead plug at the central area is laminated with alternating layers of steel plates and rubber. This bearing has a high vibration damping effect and excellent decompression capability. Accordingly, it is suitable for this structure. The specifications for the LBR are shown in Table 3.

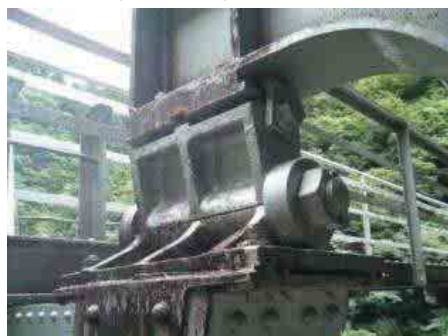
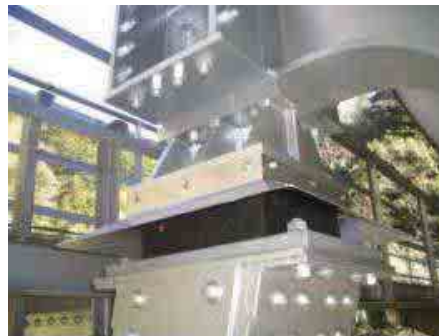
① Exchange bearing

Fig. 7: Outline of Aseismic bearing construction of the Water-tube bridge

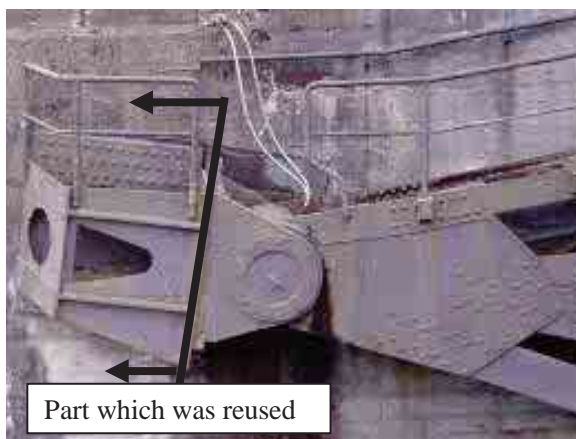
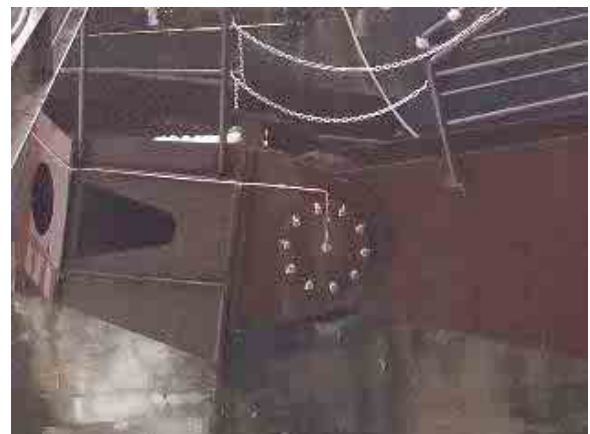
Photo 5: The status of the fixed part (Jinichi dam)

Before replacement

After replacement

The gate sheet was slightly rusted, but it was judged to be able to be saved by repainting, and thus cost savings were obtained by reusing the existing facility.

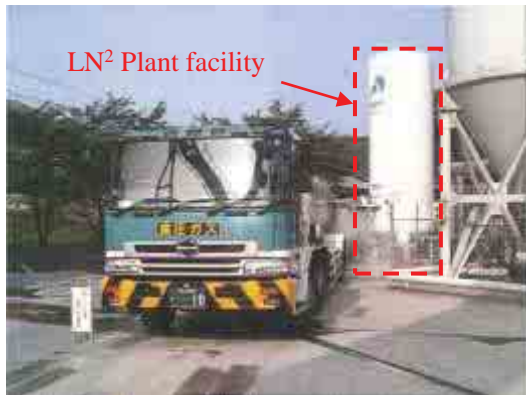
Photo 2: Liquid nitrogen (LN₂) plant facility installation status

(In the ready mixed concrete manufacturing plant)

As a result of analysis, it became obvious that there was a fear of an impact of a temperature increase accompanying concrete pouring construction in the summer during daytime. Therefore, pre-cooling treatment of the concrete by liquid nitrogen (LN_2) was conducted. For the pre-cooling method, two methods, that is, the plant mixer input method and the truck mixer site input method were considered, and the former was adopted because it was easy to control temperature at the time of input (Photo 2). From the result of the temperature analysis, an injection temperature for pre-cooling was targeted to be 20 °C, and from 2004 to 2005 (June to September) this process had been followed. The cooling basic unit of liquid nitrogen which shows the concrete temperature reduction efficiency was set to be 13kg/m³ °C, and until the temperature dropped to around 10°C, the assumed effect was confirmed. On top of that, in order to decrease the rise of the concrete temperature during transport, heat insulation was installed on the external surface of the concrete mixing vehicle (Photo 3).

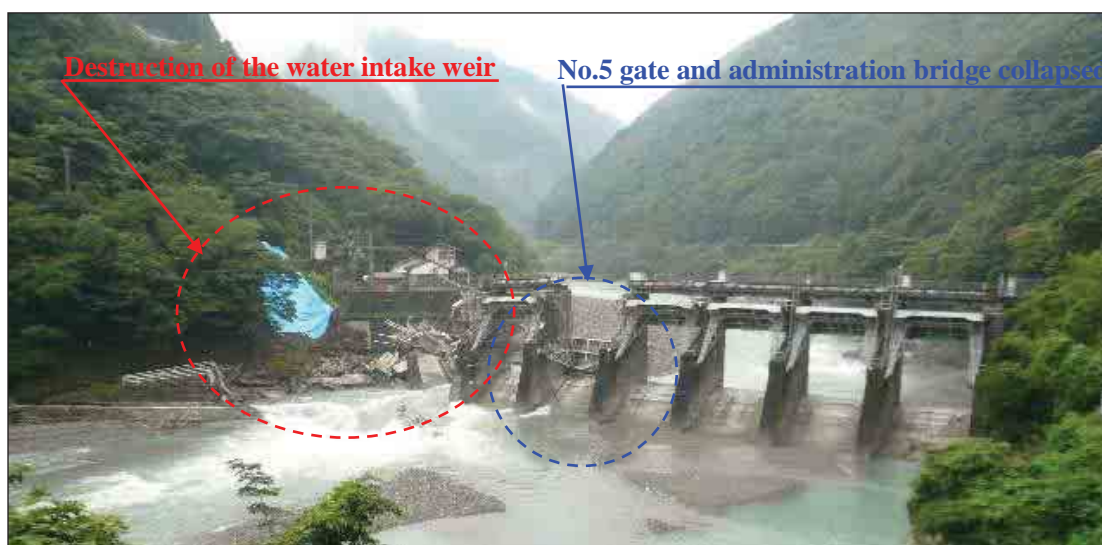
Photo 2: Distant view of the destruction of the water intake weir

This facility was constructed before the design standard for dams/weirs had been established. Therefore, the reason why this destruction occurred was as follows; none of the damaged facilities were embedded into the foundation rock, and the seepage control was not installed on the water intake weir body, so the foundation area was locally undermined by seepage water for many years. On top of that, there was a huge rain, so the revetment downstream of the water intake weir was broken down and the embankment was washed out, so it was assumed that the damage then expanded into the upstream side.

The status of the destruction of the water intake weir is shown in Photo 2, and the specifications after restoration are shown in Table 2, Fig. 2, 3, 4 and Photo 3.

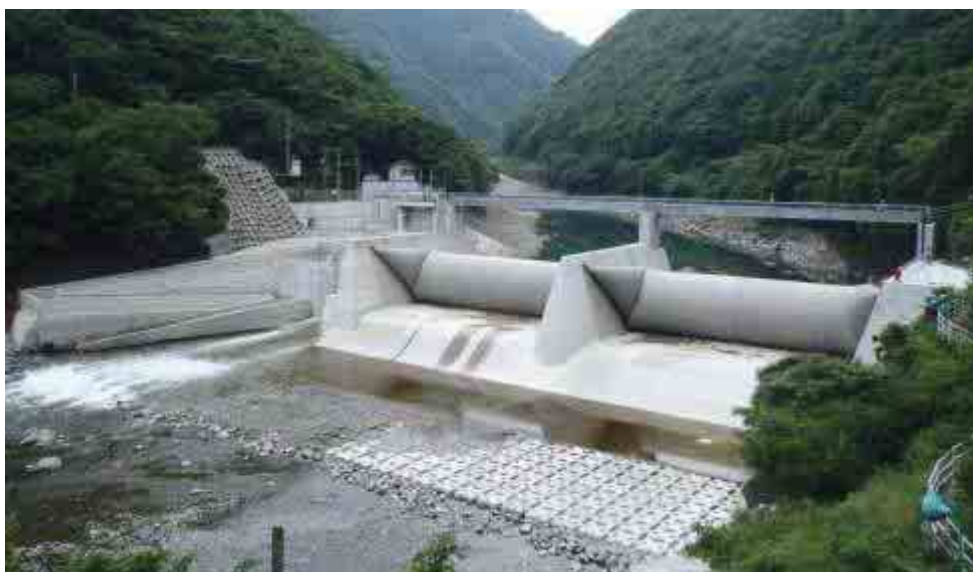
Photo 3: Photo of the water intake weir after restoration

For the seepage control work, not only from the view point of assuring creep length but also with a view to prevent sucking by the flow and/or washing out of the structure foundation, it was decided that sheet piling was to be embedded in the foundation bedrock upstream and downstream. As for the water intake and fish pass, with a view to restore them to their original status, reinforcement work was conducted as necessary.

The design of the water shielding is a steel cutoff sheet-pile (III type) structure. Since a large boulder was found in the river bed, advance excavation was conducted before construction using a large diameter boring machine. The inside of the created cavity was filled with sand, and the cutoff sheet-pile was installed. Thus, the following work was able to be quickly conducted such as: the prevention of the occurrence of lateral force to the cutoff sheet-pile, confirmation of whether the cutoff sheet-pile reached the supporting bedrock or not, and confirmation of the excavated length of the foundation (more than 1.2m).

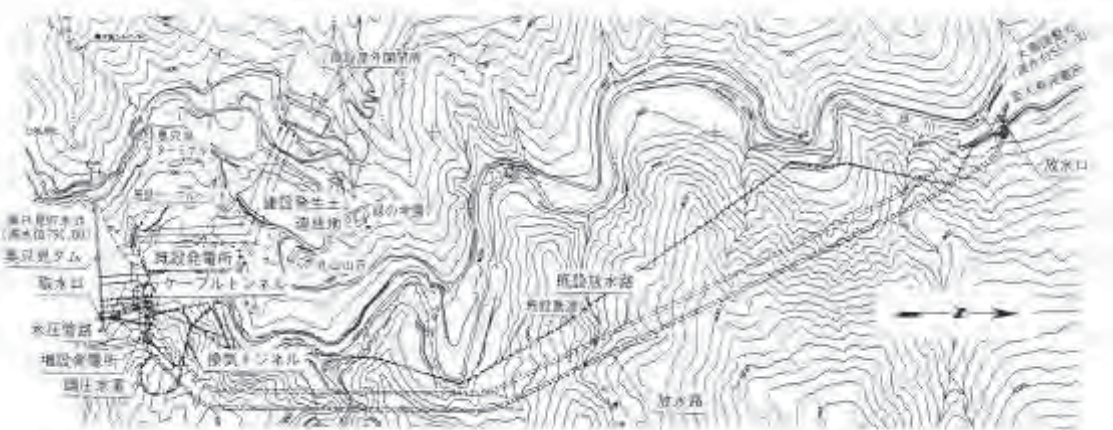
Fig. 7: Plan view of the planned Okutadami expanded power station

This project aimed to generate a maximum output of 87,000kW by increasing plant discharge by a maximum of 207 m³/sec by using the added plant discharge from the expanded Okutadami Power Station and by obtaining an effective head of 48.1m. The expanded water intake was installed on the right bank of upstream of the Ohtori Dam. The hydraulic pipe was installed as an inclined shaft and water is delivered to the underground power station. Water used for generation passes through the tailrace which was prepared by expanding the temporary discharge channel made for the expansion of the Ohtori Dam and is discharged into the Tagokura Reservoir from the outlet. The plan view and the longitudinal cross-section of the planned expanded Ohtori Power Station are shown in Fig. 9 and Fig. 10. The specifications are shown in Table 1.

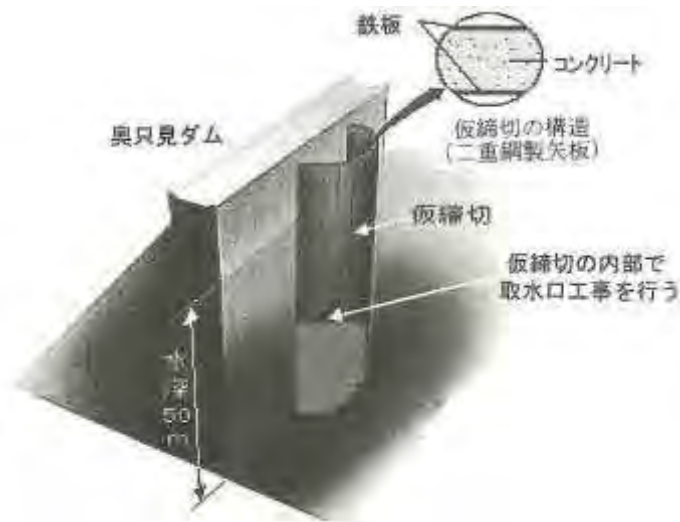
Fig.11: Outline of the makeshift cofferdam

This makeshift cofferdam has a structure with a radius of about 8m which resists water pressure by the axis force. Outline of the makeshift cofferdam is shown in Fig. 11. This was a cell type makeshift cofferdam which was made up of 13 box type steel sheet-piles with an arch length of about 8m in the circumferential direction, and 4 steel sheet-piles vertically. The inside of the box type steel was filled with underwater concrete. These actions made it possible for the relatively thin 65cm structure to function as a makeshift cofferdam against the tough pressure conditions of the 50m installation depth.

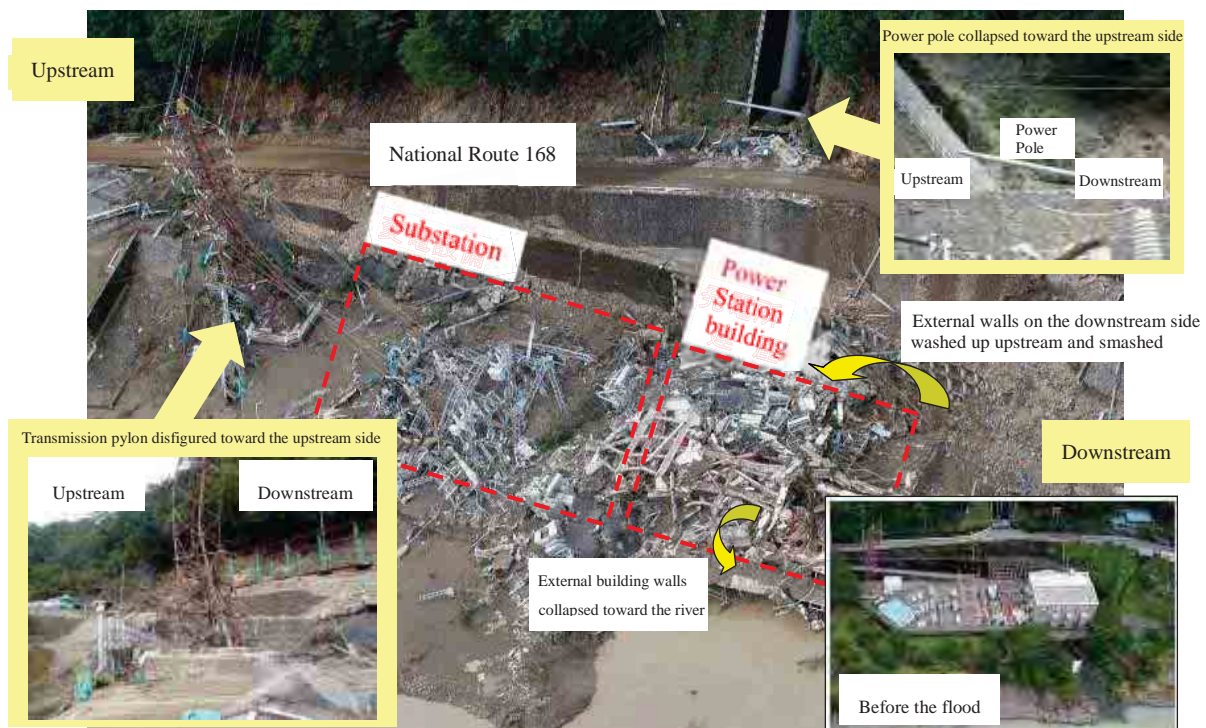
Fig. 2: Damage status of the Nagatono Power Station

Firstly, we examine the mechanism that led to the damage of the power station. Figure 2 shows the status of damage suffered by the power station, and Figure 3 shows the highest level of water marks left. The presence of external force from downstream to upstream is suspected due to the facts that some power poles had fallen toward the upstream side, and that external walls on the downstream side had been found to have moved and smashed upstream. Water mark traces are identified at very high levels in the section 350 – 850 meters downstream from the power station. This corresponds to the area of a large-scale slope failure, indicating that the sand and soil that fell into the river directly gauged riverbanks.

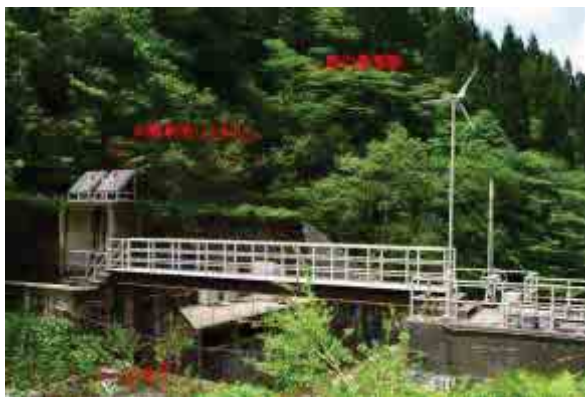
Solar energy	Maximum 336 W
Wind energy	Maximum 3,200 W
Storage battery	105A×8batteries

Fig. 4: View of the installation of solar cells and wind power generator

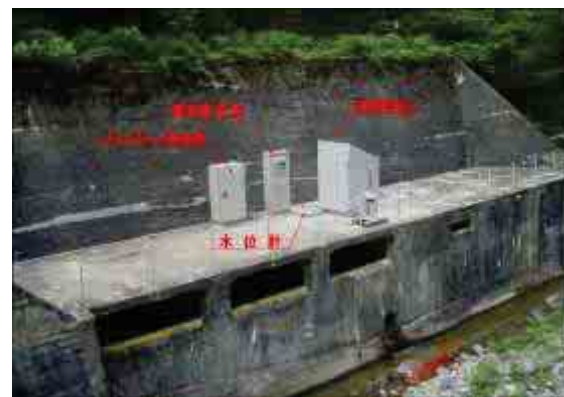
Fig. 5: Equipment of the automatic control system responding to water volume

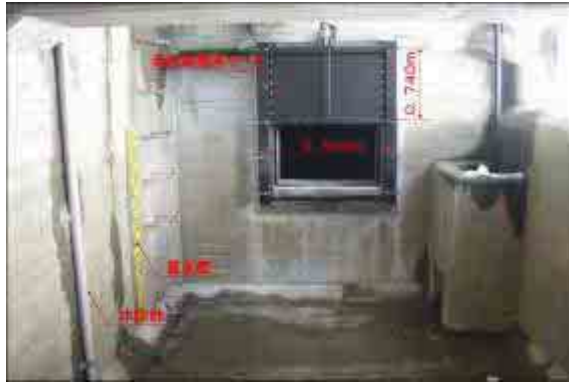
Fig. 6: View of the headrace regulating gate

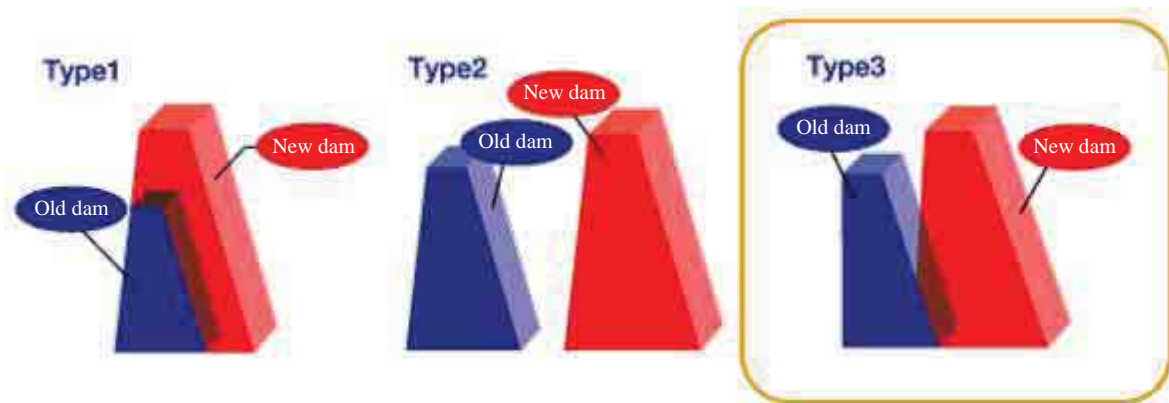
The Shin-Maruyama Dam is to be raised on the largest scale in Japan for a large-scale multi-purpose dam. The existing Maruyama Dam plays an important role in regulating the flooding of the Kiso river's main stream and also in the company's power generation business. Its functionality must be maintained even during the construction work. The project is expected to apply advanced technologies in terms of design and construction methods.

Fig.4 Dam raising methods

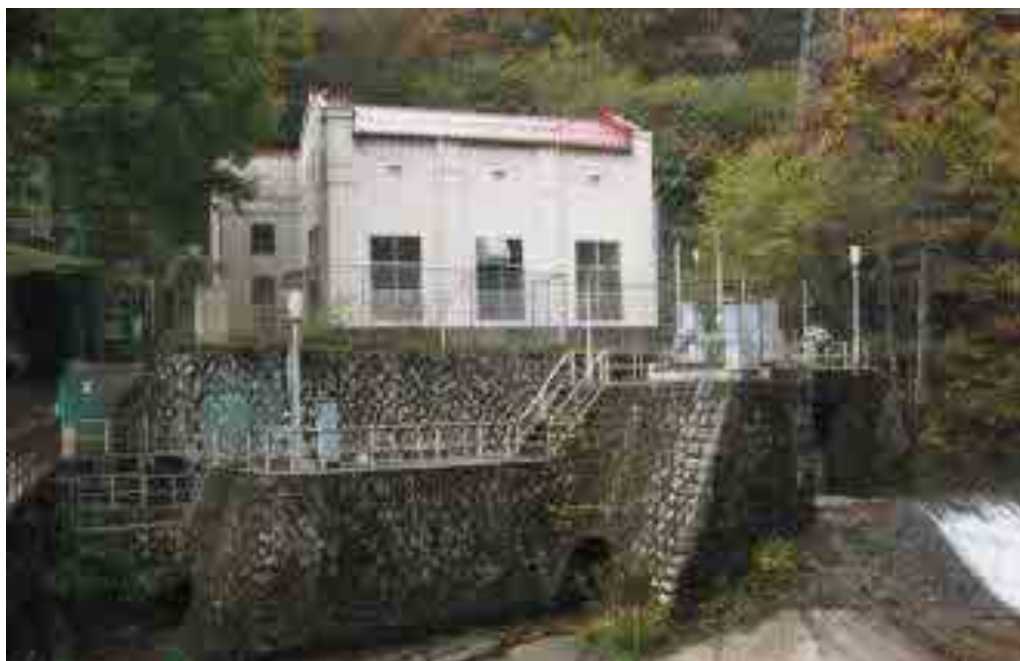
Fig.2 Kumagawa Daiichi Power Station (before the renewal)

The renewal makes diverted use of civil engineering facilities to cut costs, improves the turbine's efficiency to boost power generation, implements sediment abrasion countermeasures on the turbine's water flow areas to extend the cycle of turbine repair, and eliminates auxiliary equipment to reduce maintenance work. Table 1 shows the specifications of the Kumagawa Daiichi Power Station before and after the renewal.

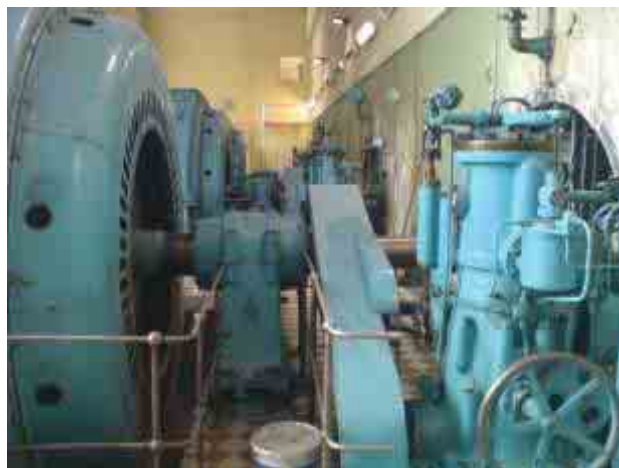
Embretsfoss II (E2, west bank) with 3 x 3 MW Francis units and a total capacity of 75 m³/s water was commissioned in 1921 and was still in operation. It was more or less in original condition and was closed down in 2013, after commissioning of Embretsfoss IV. The turbine runners were replaced in 1955.

Embretsfoss II, commissioned in 1921 and still in operation in 2012

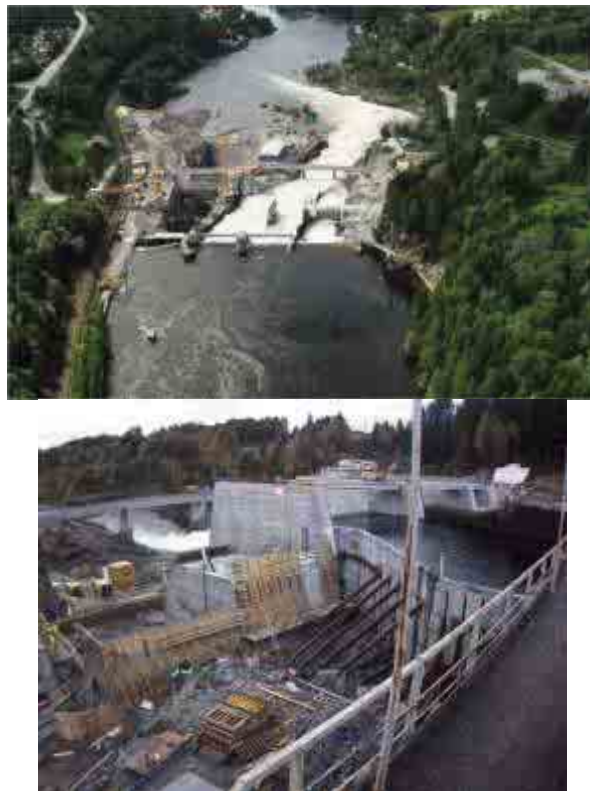
The future required flood capacity had to be met by increasing gate size and fixed spillway capacity. Since the flood gates make up a significant part of the dam, with regard to both size and cost, it was found more cost efficient to build a new dam downstream existing dam. This made it easier to maintain normal production in the existing powerhouses (E2 and E3 during construction). An additional important function of the flood gates is to control and maintain stable headwater level when having surplus water. Due to good experience from a previous project, two 20 x 7 m radial gates were chosen.

Dam under construction (June 2011) and western area with new flood-gates in operation (Oct 2012)

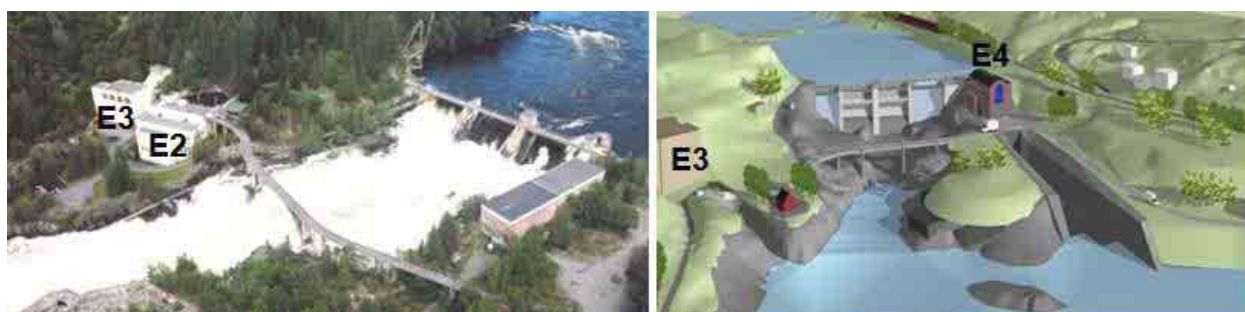
Building a new powerhouse at opposite river side gave opportunity to optimize the capacity. The intake could be integrated in the new dam without reducing dimensioning flood capacity. A single large Kaplan turbine (52.5 MW at head 16.3 m with runner throat diameter D2 = 6.7 m and rotational speed 93.75 rpm) was chosen. This gives annual some 140 GWh additional new renewable power production. Two smaller units instead of a single unit were considered, but this is a more costly solution, and existing unit at E3 will be in operation for many years with significant capacity (up to 150 m³/s). By building a new powerhouse, full operation of E2 without any downtime during construction period was possible. In addition, the new powerhouse more than doubled the capacity and also increased the total plant efficiency with approximately 15% at 250 m³/s. This is a solution with at least 50 years horizon.

Arrangement of old (E2 and E3) and new (E3 and E4) power houses

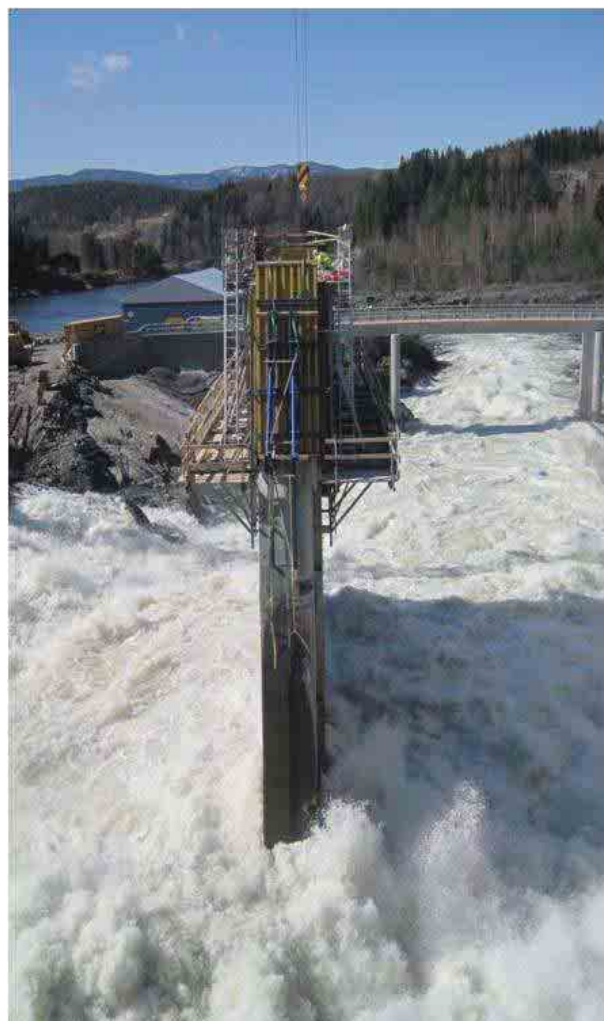
The main challenge for the project execution was a more or less continuous flood period from primo June to primo October in 2011. The flood in this 4 months period was in the range of 700 – 900 m³/s, peaking to about 1 000 m³/s from time to time. Normal flow in this period should be 170 – 200 m³/s. The project was well prepared and had a temporarily flood diversion capacity of 1 400 m³/s. This seldom summer flood (worst since recording was started more than 100 years ago) caused some shift from summer work to winter work without delaying the project.

Construction of center dam pillar during flood, 2011

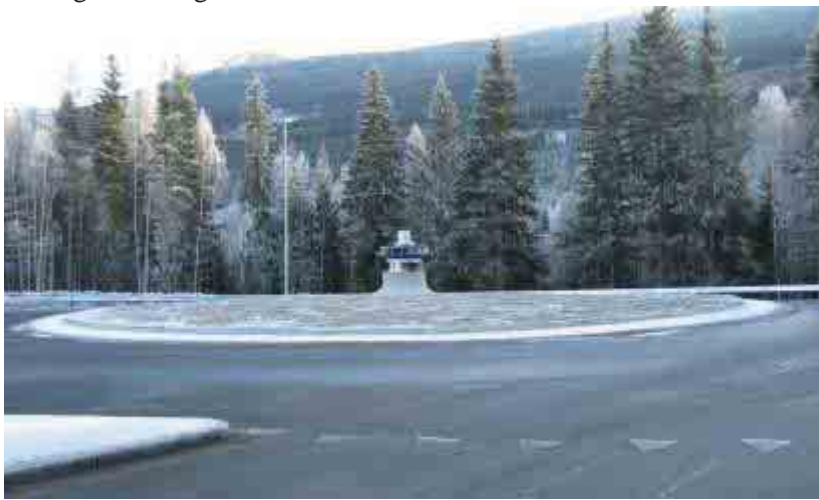
Old Hemsil 2 turbine runner, now decoration in a roundabout 3 km from the plant.

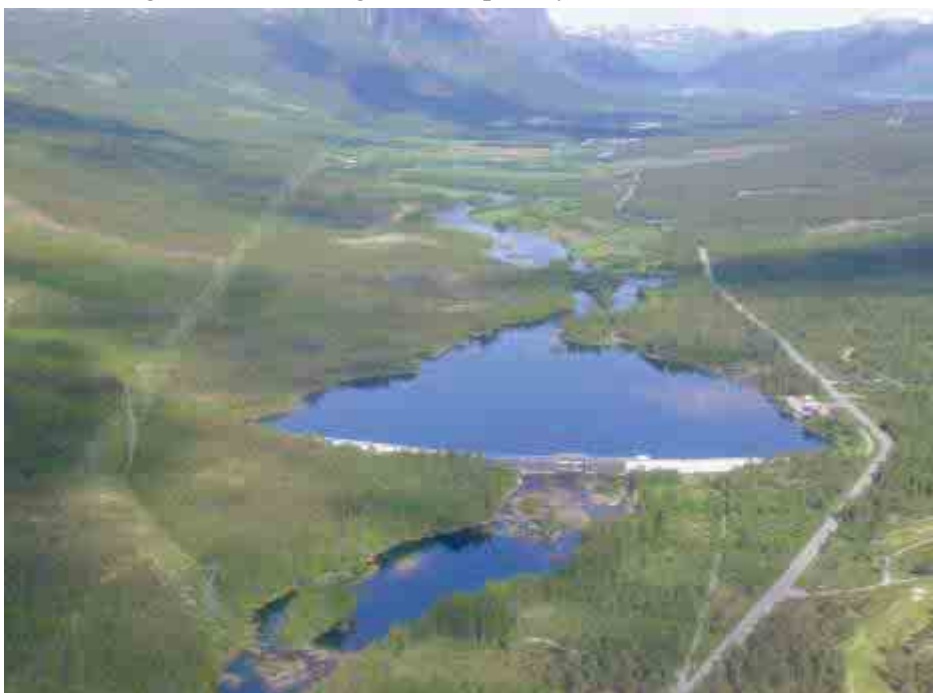
Hemsil 2 HPP utilizes a water fall with gross head 370 meters in the river Hemsil, from the small intake pond Eikredammen on 566 MASL to the river Hallingdalselva by Gol on 196 MASL. The intake pond is a small artificial lake called Eikredammen. Dam Eikredammen is a concrete dam, 8-12 m high, 500 m long, with two flood gates and spillway.

Photo of Eikredammen (2012)

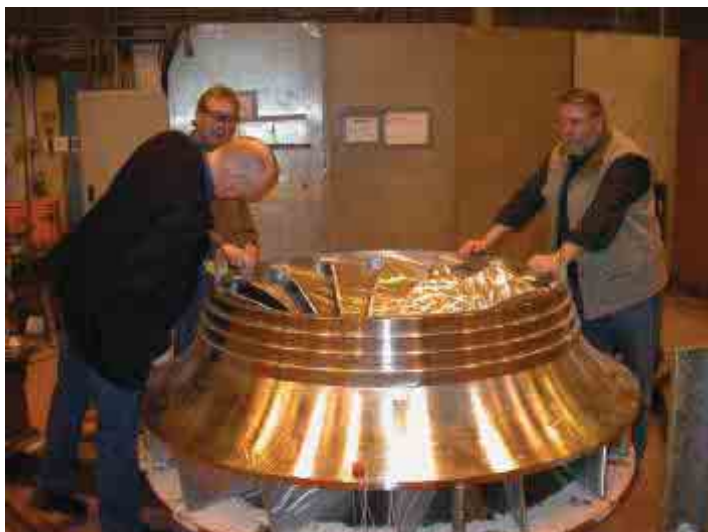
Inspection of one of the new turbines.

The results from the initial analysis were used as a basis for the technical specifications in the tender documents. The tender documents were set up so tenders could offer an improved efficiency if their technology could provide better results. The accepted vendor guaranteed efficiency close to 95%, and capacity of 49 MW for each turbine.

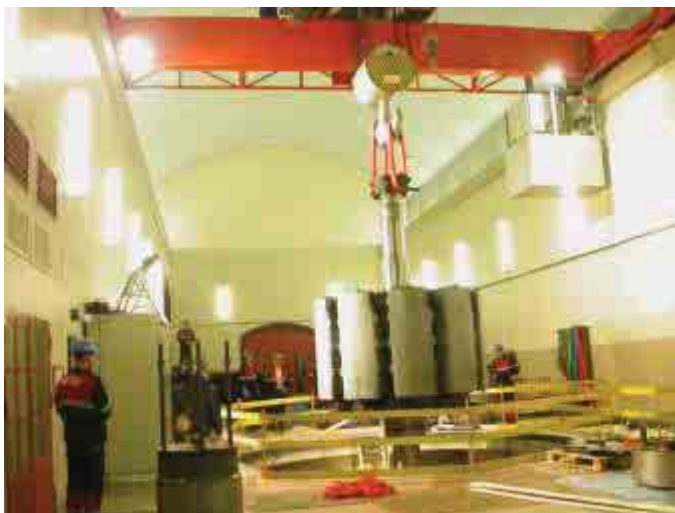
Hemsil 2. Power house with generator.

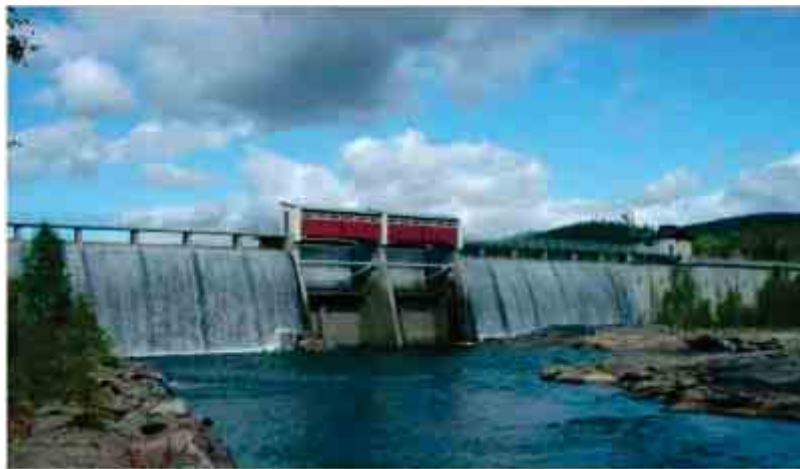
The intake pond Eikredammen has limited storage capacity (0.4 Mm³)

The existing Hemsil 2 HPP utilizes a water fall with gross head 370 meters in the river Hemsil, from the small intake pond Eikredammen on 566 MASL to the river Hallingdalselva by Gol on 196 MASL. The headrace tunnel is 15.4 km long with a cross section area of 10-18 m². The old station with tunnels has low capacity, and there is a significant water loss in the system.

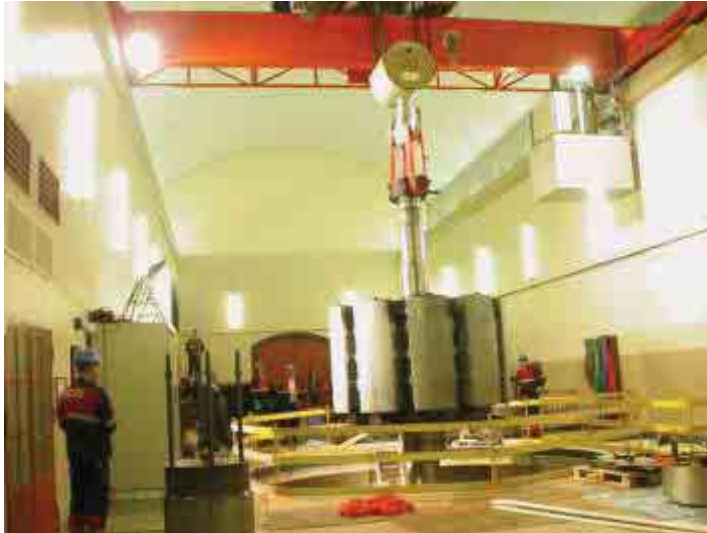
Hemsil 2. Powerhouse with generator

Hemsil 2 power station was built underground in 1959-1960. There are two Francis turbines in the power station, each with capacity of 49 MW after upgrading in 2004-2006. Total design discharge today is 31 m³/s. After upgrading, Hemsil 2 HPP's mean annual production is set to be approximately 537 GWh.

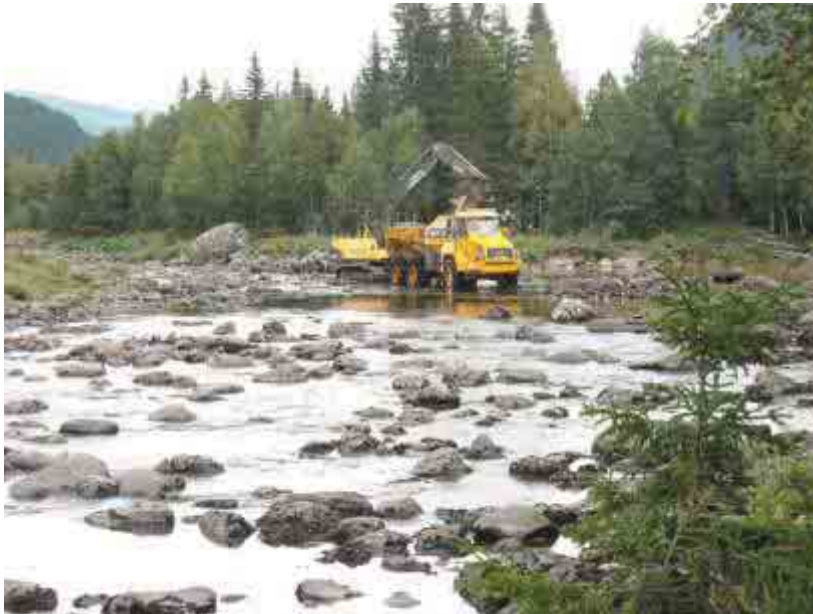
Improving the water landscape in Hemsil by concentrating the river stream (2010)

In the application, E-CO Energi suggested a minimum water flow (ecological water flow) of 200 l/s in summertime (15th of May to 30th of September) and 50 l/s in wintertime (first of October to 14th of May). This is twice the voluntary environmental water flow which started in 2011, and represents a loss of power production of 2-3 GWh compared with no requirements. It is E-CO Energi's opinion that this level of water flow, together with fish-friendly measures in the river bed, will safeguard rare plants and improve fish spawning and living areas.
