- River Maintenance-intended Outlet Structure

**Project Name:** Futagawa Dam

Reduced Flow River Caused by Diversion, Ecosystem, Compensation Flow

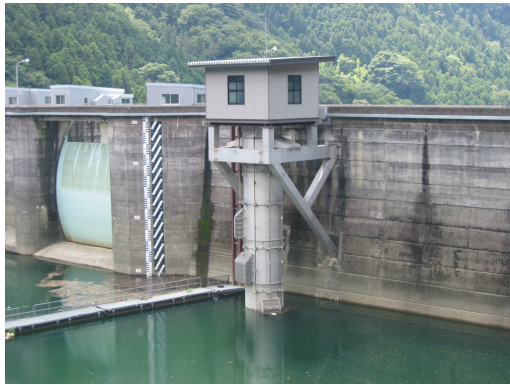
Photo 1 Intake tower of outlet structure for compensation flow

The objective of the Futagawa Dam Water Environment Improvement Project was to embed an outlet pipe (400 mm in diameter) in the dam body, for normally discharging 0.7 m<sup>3</sup>/sec of water for compensation flow in the downstream section. The project started in 1993 with a total project cost of 1,410 million yen, and the compensation flow started on May 26, 1998.

Photo 1 shows the appearance of the completed outlet structure, and Figure 3 shows the schematic view.

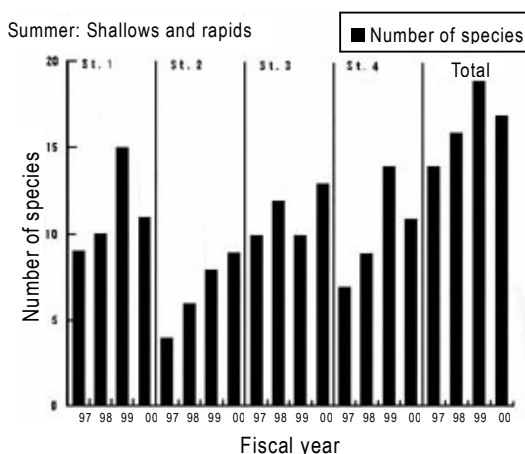
Figure 5 Number of species with lapse of years

In reference to the species confirmed in FY1997 to FY2000, there were no large differences in either the species confirmed or the number of species confirmed. However, the number of species confirmed in shallows and rapids tended to increase, although the number of species confirmed before the start of the compensation flow was smaller (Figure 5).

From the above, it can be considered that although only some fish could live in shallows and rapids due to the small water depth before the start of the compensation flow, the compensation flow increased the water depth and promoted the thick growth of vegetation along the waterfronts, allowing more species of fish to live there. Furthermore, at St. 1 and St. 2, *Rhinogobius* sp. CB and *Rhinogobius* sp. LD, migrating fish that were not confirmed in FY1997 before the start of the compensation flow, were confirmed after FY1998 inclusive subsequent to the start of the compensation flow. The reason for this is considered to be that since there are no longer any sections devoid of running water in St. 3, fish can always migrate into a section to which they could migrate only when water was discharged from the dam, and therefore *Rhinogobius*, considered less anadromous than *Plecoglossus altivelis*, could also migrate upstream. The conditions at St. 1 and St. 3 before and after the start of the compensation flow are shown in Photos 2 through 5.

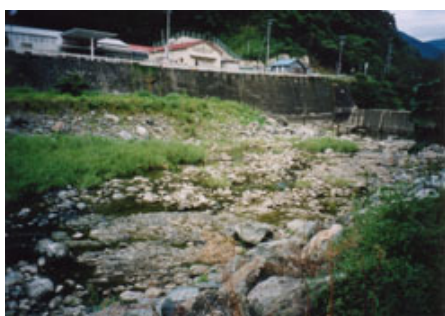
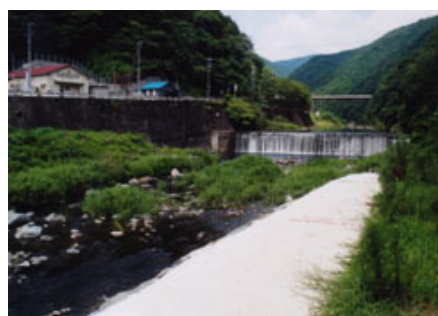
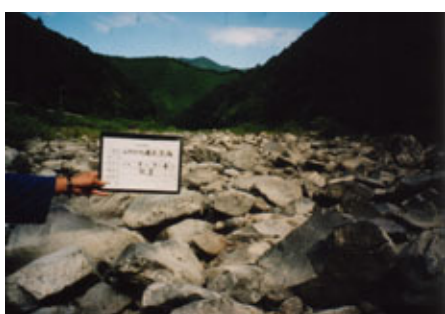
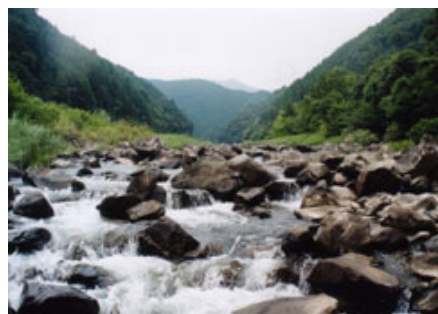
Photo 2 Conditions at St. 1 before start of compensation flow

Photo 3 Conditions at St. 1 after start of compensation flow

Photo 4 Conditions at St. 3 before start of compensation flow

Photo 5 Conditions at St. 3 after start of compensation flow

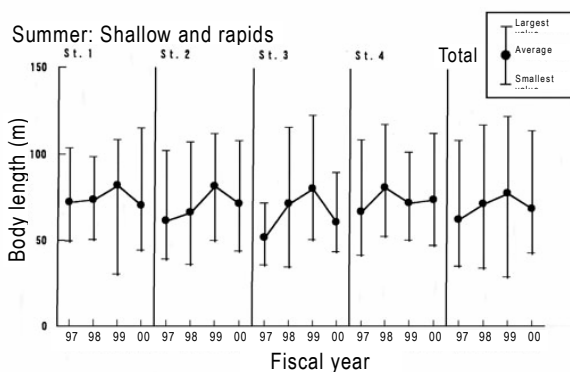
Figure 6 Changes in body length of *Zacco Platypus* with lapse of years (summer survey: shallows and rapids)

*Zacco platypus* is a typical fish species for shallows and rapids. The changes in the body length of *Zacco platypus* at the respective stations with the lapse of years are shown in Figure 6. At St. 1 to St. 3, compared with the values of FY1997, the values of FY1998 and 1999 are remarkably larger. However, the values of FY2000 do not differ from those of FY1997.

These results suggest that up to FY1999, the prey quantity per fish was so large as to increase the body length, since the population density remained unchanged while the prey environment was improved. However, in FY2000, the prey quantity per fish became so small that the FY2000 body lengths did not differ from those of FY1997, since the population density became higher while the prey environment in FY2000 was the same as that in FY1999.

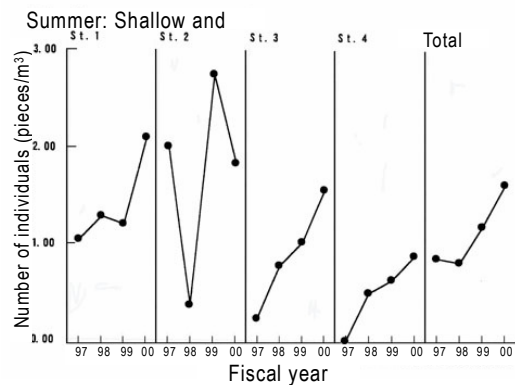
Figure 7 Changes in population density of *Zacco Platypus* with lapse of years (summer survey: shallows and rapids)

Figure 7 shows the population density of *Zacco platypus* per unit area. It can be seen that compared with the values of FY1997, the number of individuals per unit area increased significantly.

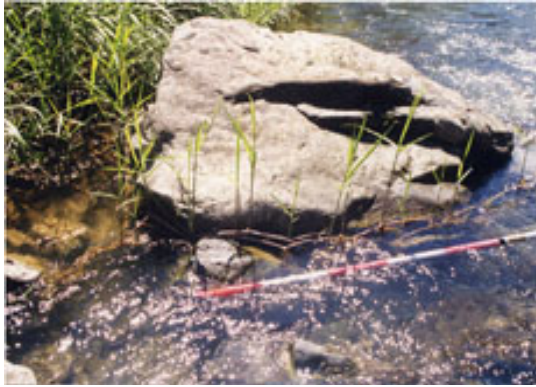
Photo 6 Phragmites Japonica having growing runners

Since the start of the compensation flow, the habitat range of *Phragmites japonica* has expanded (Photo 6), accompanying the deposition of soil, and in this connection, *Alnus serrulatoides*, *Salix chaenomeloides*, and so on were confirmed by the FY1999 survey to have taken root. Furthermore, in the FY2000 survey, their seedlings were confirmed, and successively up to the last fiscal year, the number of species of waterfront plants and the expansion of their habitat ranges were confirmed.

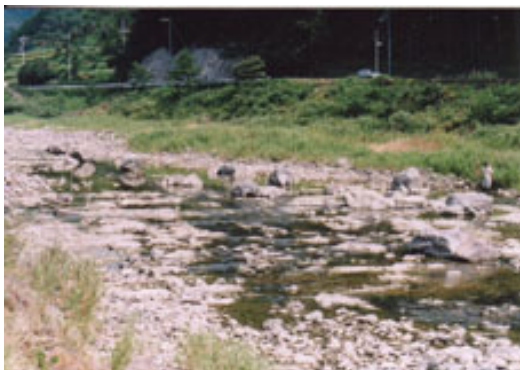
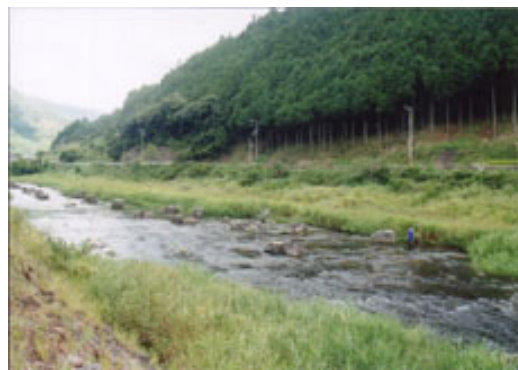
Photo 8 River regimes before start of compensation flow (St. 2)

Photo 9 River regimes after start of compensation flow (St. 2)
