Key Issues: 10- Landscape and Cultural Heritage

Project Name: Chinda Power Plant

Country: Oita Prefecture, Japan (Asia)

Recreation of original beauty, new design method, tourism

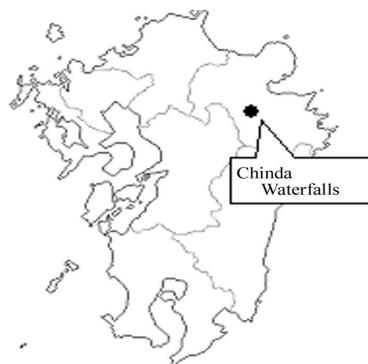
Fig.-1 The Position of the Chinda Waterfall

The Chinda Hydroelectric Power Plant, situated in Ono-cho in the central part of Oita Prefecture, is a run-off-river type hydroelectric power plant with a maximum output of 8,300kW and a maximum usable discharge of 25.04m³/s (See Fig.-1).

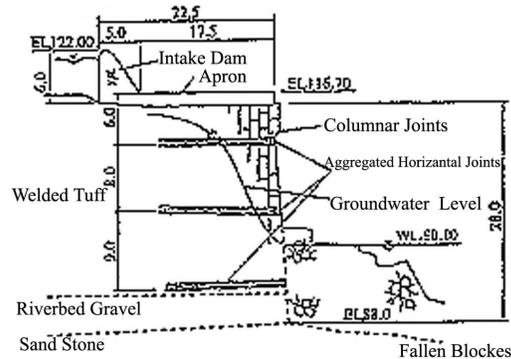
Fig.-2 Geological Profile

Fig.-2 shows geological features of nearly the center part of the waterfall. The falls is composed of welded tuff (Fig.-3) and sandstone of the Mesozoic Era forms the basement. Between them, an unconsolidated sandstone layer, old river bed sediment, deposits in a thickness between 1 and 6 meters. The welded tuff is strongly welded, with the rock mass having an average unconfined compressive strength of 48 MPa but it is a discontinuous rock mass in which columnar and horizontal joints highly developed. The observation of the waterfall surface and boring cores revealed that horizontal joints aggregated densely in three points where they continued at intervals of 10 m or so and that columnar joints had perpendicular continuity at intervals of 1 to 2 m. In the basin of the waterfall, fallen blocks of rock piled up as if they suppressed the foot of the waterfall surface, suggesting that the falls fell down repeatedly in the past. Thus, it was feared that leaving the falls as they were might lead to bursting of the dam situated in the immediate upstream.

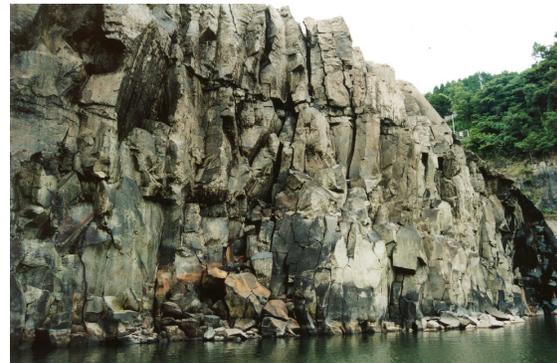
Fig.-3 Welded Tuff on the Surface of Waterfall
